## Failures in Concrete and water damage management

This paper explains how normal day to day procedures in restoration have caused unnecessary claim costs and delays and how new technology can reduce insurance claim costs.

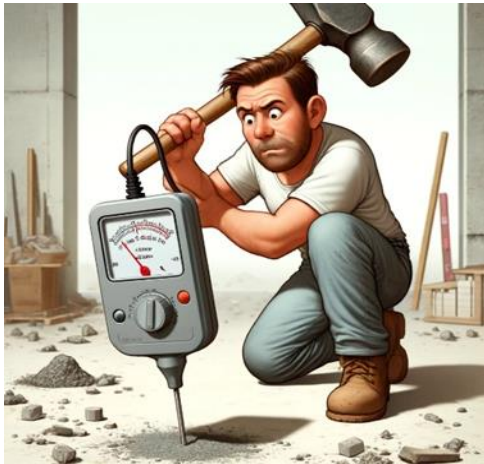
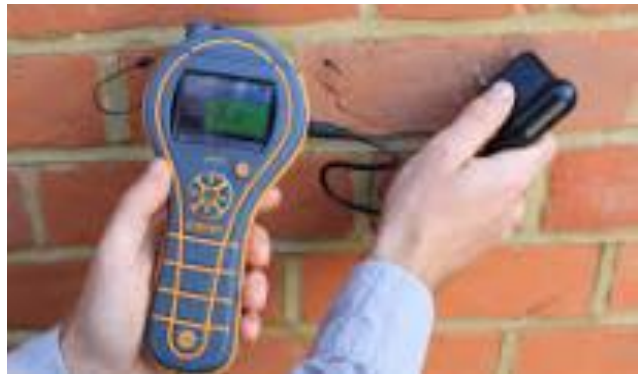
Water damage restoration is a major cost to insurers and property owners and unfortunately, much of the cost is swallowed up by following measurement protocols that simply don't work. If I asked how to measure a wet concrete floor most would suggest a moisture meter and most would recognise the failure shown in the first two examples shown below. But how many have used the following equipment and have raised concerns on outcome?

**Photo by Protimeter  
Using the wrong methodology ?**

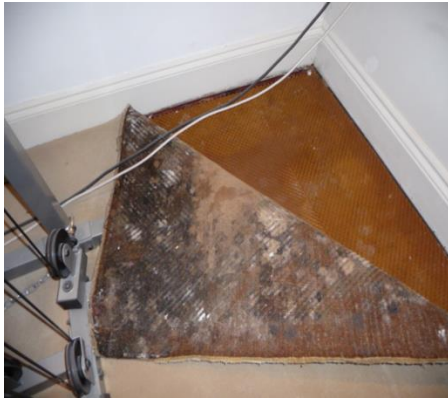
**But the floor was dry before I laid the flooring ?**

Failure to measure moisture content properly post water damage and prior to laying resilient flooring can result in failure, unnecessary costs and damage.

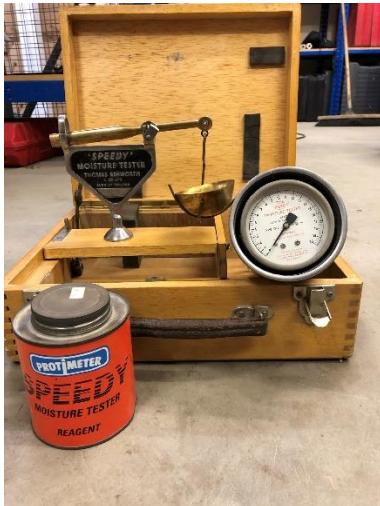
We start with obvious failures in using moisture detection equipment and the photo of delicate steel pins being hammered into masonry is unfortunately not far from reality.

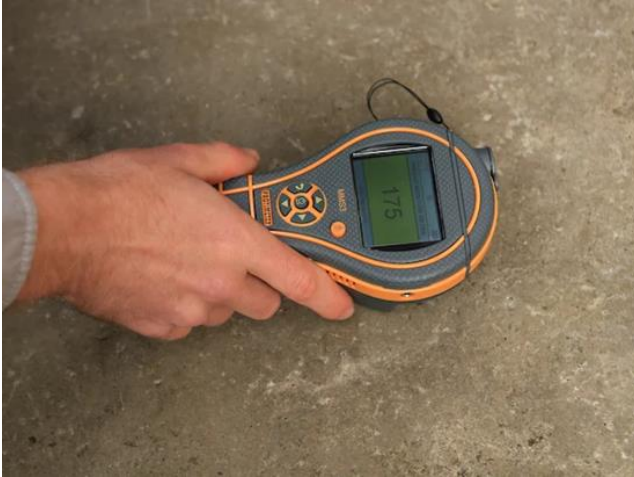
It is presumed and accepted that the calcium carbide meter, or also referred to as the speedy meter, is in fact the most reliable form of moisture measurement.

Most don't follow the guidance as per BRE DG245 and even if they did its results are possibly worthless in concrete measurement.

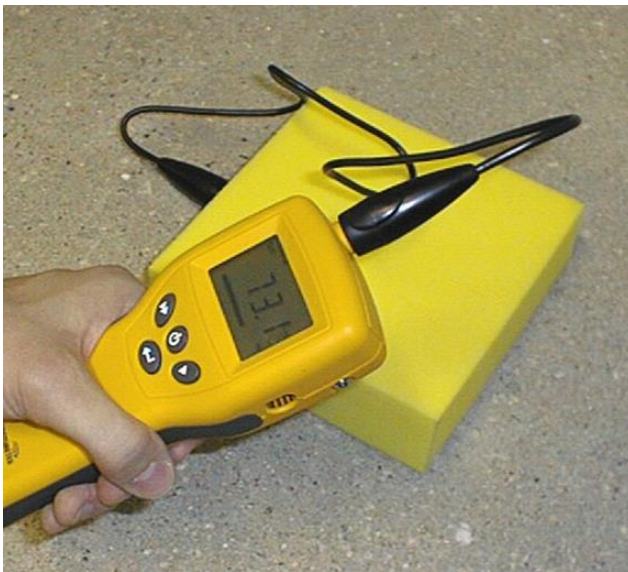
The Protimeter set in non destructive impedance mode provides almost worthless information

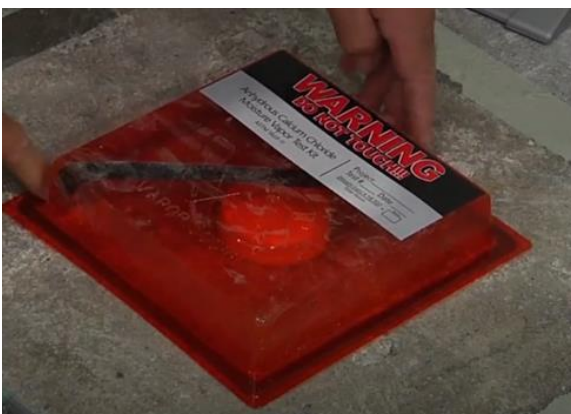
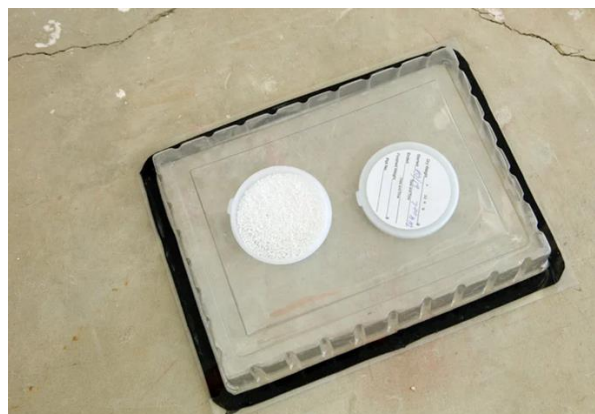
The humidity box used for years provides worthless results.

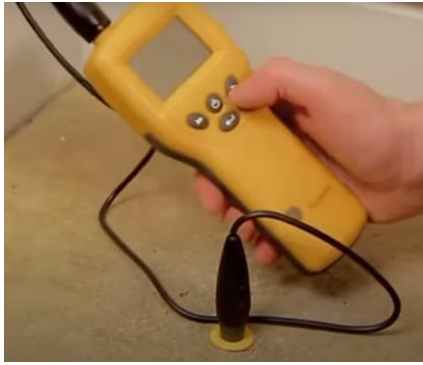
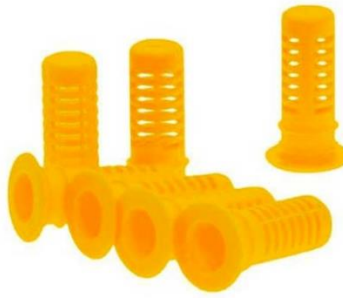
Another adaption of the humidity box test is the Calcium Chloride Dome test. This is where a weighed measure of calcium chloride is left in a sealed dome for a specified period and re weighed. (Major failures)

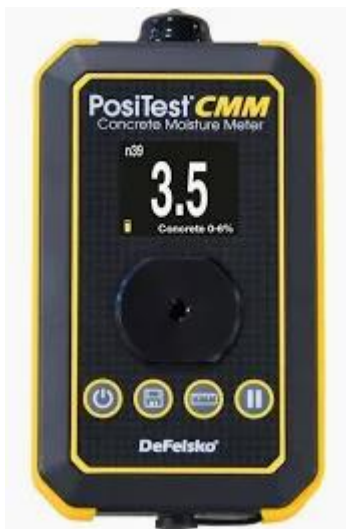
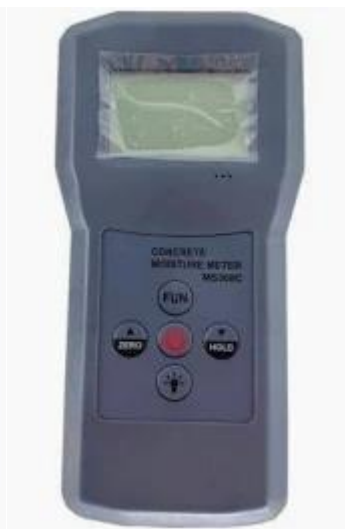
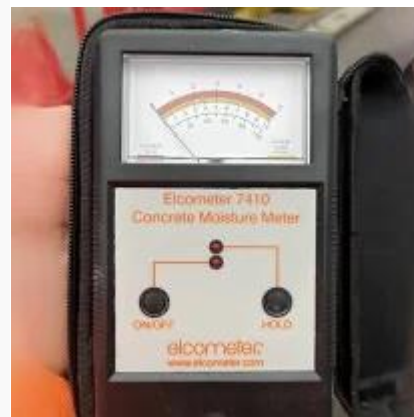
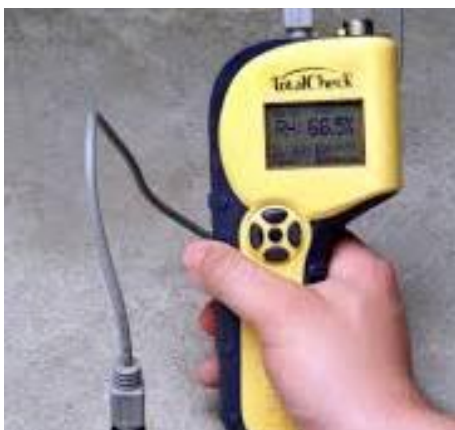
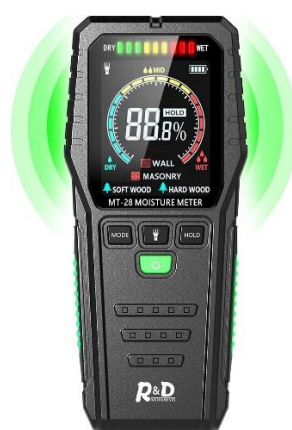
Short sleeves into concrete to measure specific humidity (major failure)

The following list of concrete meter manufacturers show ranges from £150 to £800  
None comply to realistic requirements regarding moisture content of concrete .

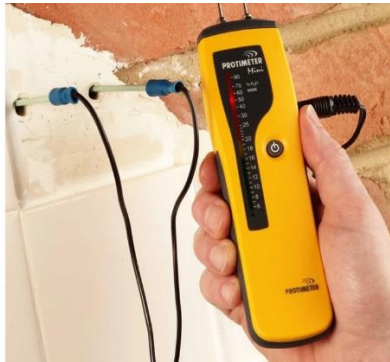
The following two conductive probe tests are worthless in terms of concrete moisture content and risk.

Two methods of  
conductivity moisture  
meter evaluation.

Neither are accurate.
